INDOOR AIR QUALITY ASSESSMENT

**Wales Town Hall
3 Hollow Road
Wales, Massachusetts**

Prepared by:
Massachusetts Department of Public Health
Bureau of Environmental Health Assessment
Emergency Response/Indoor Air Quality Program
August 2003

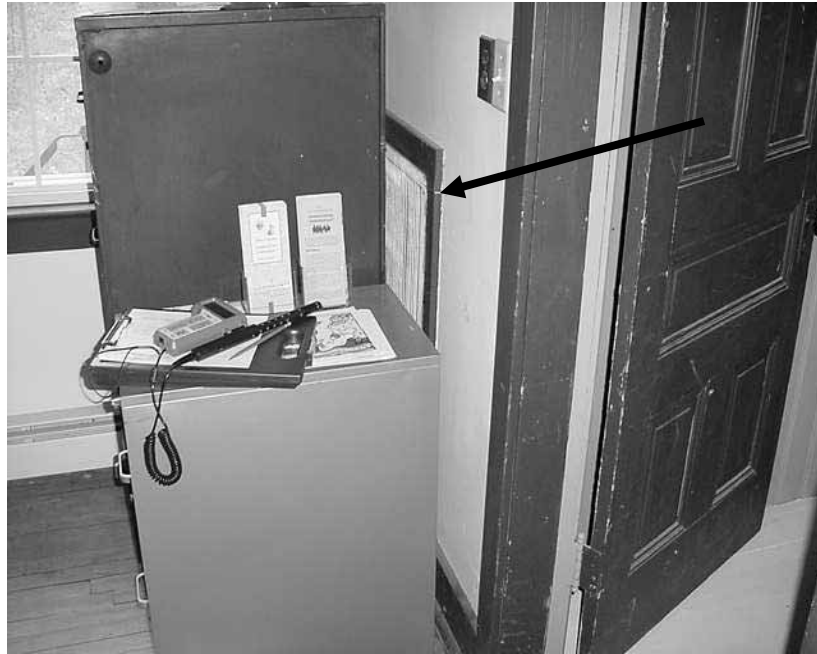
Picture 1

It appears that the building was originally equipped with a gravity exhaust ventilation system (Pictures 1-3). No airflow was detected in any of the exhaust vents examined. A louver located inside the duct controls airflow. Above the louver is usually a heating element that creates airflow that would exit the building through an airshaft via rising heat. This process is referred to as the “stack effect.” It is possible that exhaust air is removed from the building by a deactivated fan/motor located in a cupola on the roof (see Picture 4). Based upon these observations, it appears that the building does not have a functioning exhaust ventilation system. Without exhaust ventilation, normally occurring environmental pollutants can build up and lead to air quality/comfort complaints.

Gravity Exhaust Ventilation System, Second Floor

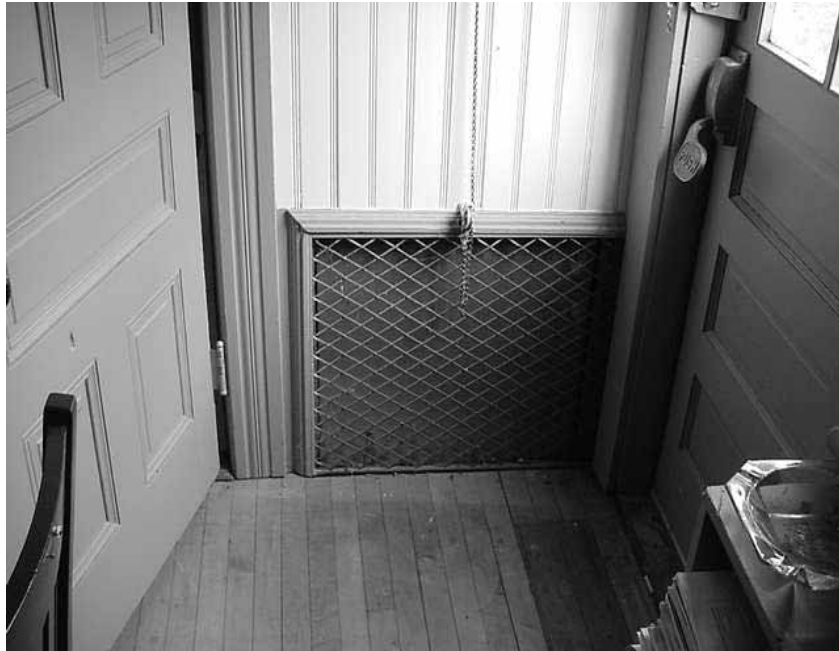
Picture 2

Gravity Exhaust Ventilation System, Second Floor

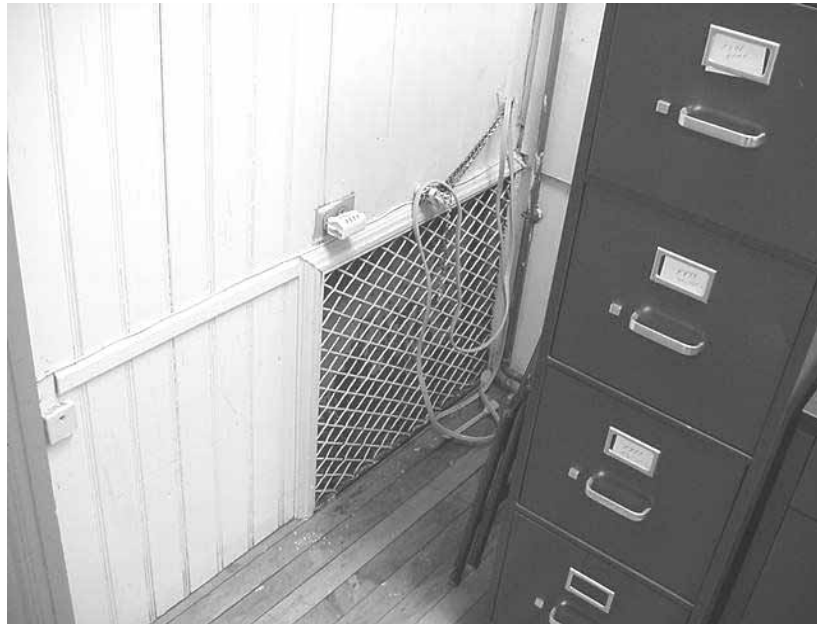
Picture 3

Gravity Exhaust Ventilation System, First Floor

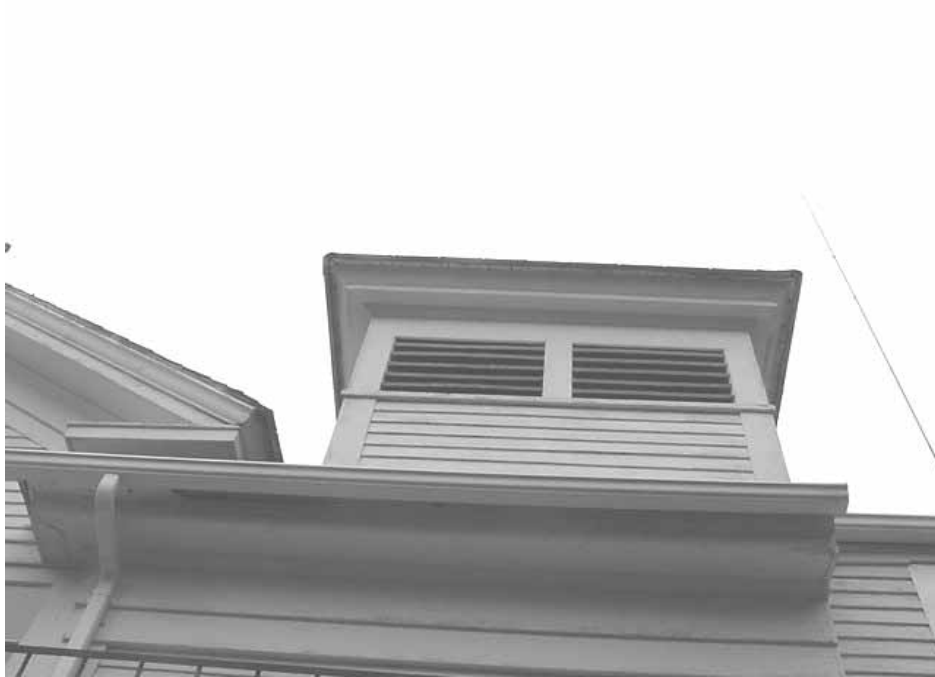
Picture 4

Exhaust Vents in Cupola on Roof

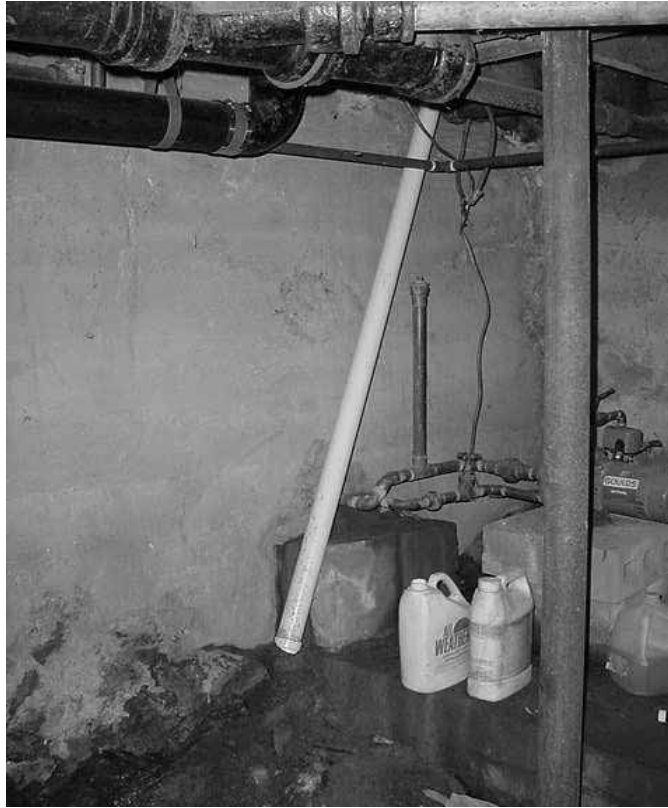
Picture 5

Several sources for water penetration exist in the basement crawlspace. A PVC pipe was found suspended in the basement (see Picture 5). Heavy water stains were noted beneath the pipe. The pipe was traced from a location in the foundation beneath fiberglass insulation and a wooden board (see Picture 6) to a dry well located uphill from the WTH (see Pictures 7 and 8). Accumulated water against the foundation can penetrate into the basement around the PVC pipe hole. Wales town officials believe that this pipe was installed as part of a groundwater monitoring system to evaluate a chemical spill located uphill from the WTH (see Picture 9). Wales town officials report that an environmental consulting firm had removed equipment from the basement, allegedly

leaving behind the PVC pipe. Two likely sources for water infiltration include: directing of water from the drywell into the basement via the pipe and rainwater penetrating through the foundation along the pipe.

Abandoned PVC Pipe in Basement

- d) Install a water impermeable layer on ground surface (clay cap) to prevent water saturation of ground near foundation (Lstiburek & Brennan, 2001).
- 8) Remove the PVC pipe and reseal the wall of the dry well and foundation.

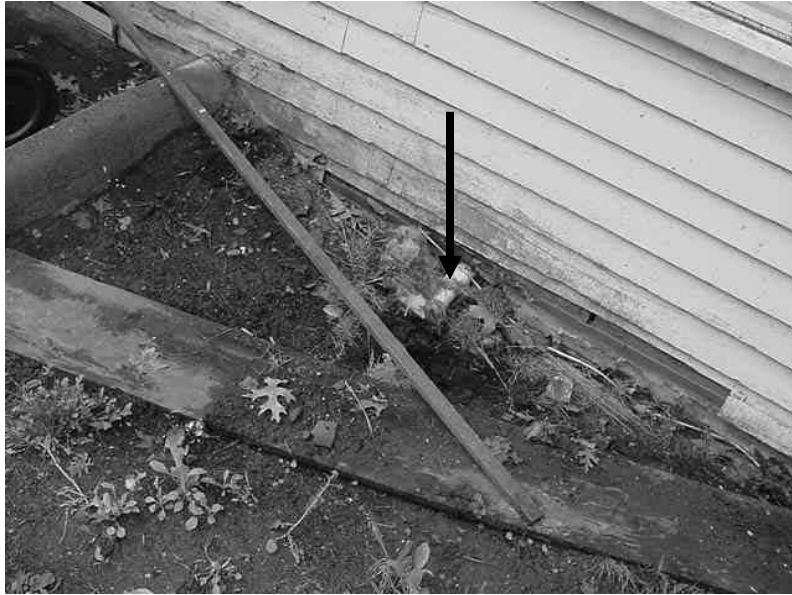
Picture 6

PVC Pipe in Picture 5 Traversing the Foundation Wall

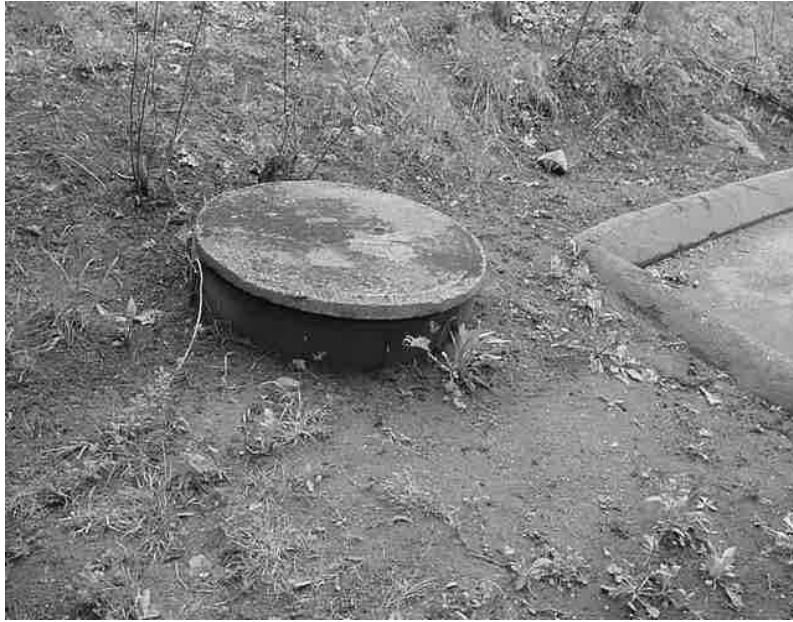
Picture 7

Dry Well

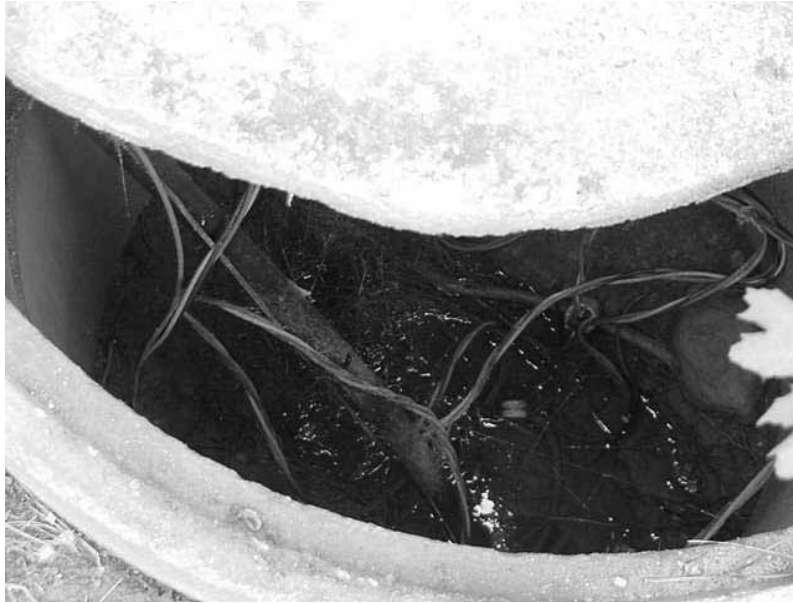
Picture 8

Hose and Wiring Inside Of Dry Well Wall

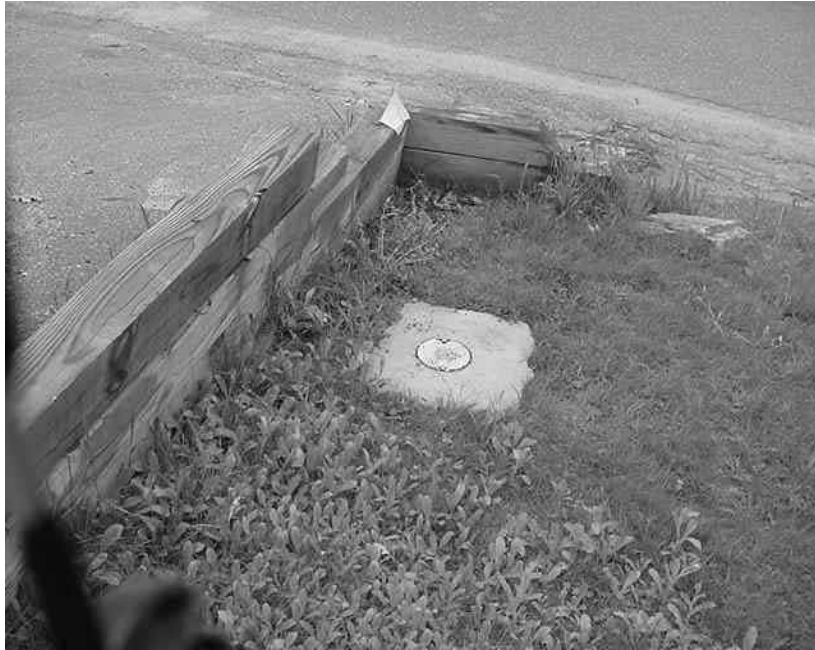
Picture 9

Monitoring Well At Corner of Property

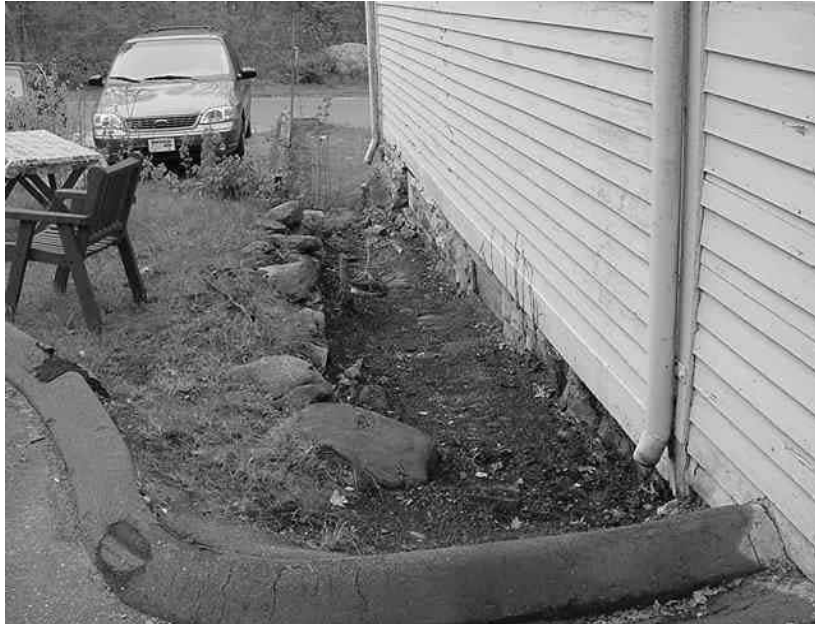
Picture 10

The gutter/downspout system also plays a role in allowing moisture to penetrate into the basement/crawlspace. A downspout empties into a trough-like area, which directs rainwater against the foundation (see Picture 10). Over the years, this run-off has created a trench around the base of the wall. This trench allows rainwater and melting snow to pool against the foundation. In addition, the shrubbery growing against the foundation wall (Picture 11) can bring moisture from roots into contact with wall-brick. Eventually, the roots cause cracks and/or fissures in the foundation below ground. Over time, this process can undermine the integrity of the building envelope and provide a means of water entry into the building via capillary action through foundation concrete and masonry (Lstiburek & Brennan, 2001).

Downspout Emptying against Crawlspace Section of Foundation

- a) Examine the feasibility of directing downspout water away from the base of the foundation wall at the rear of the building.
 - b) Improve the grading of the ground away from the foundation at a rate of 6 inches per every 10 feet (Lstiburek & Brennan, 2001).

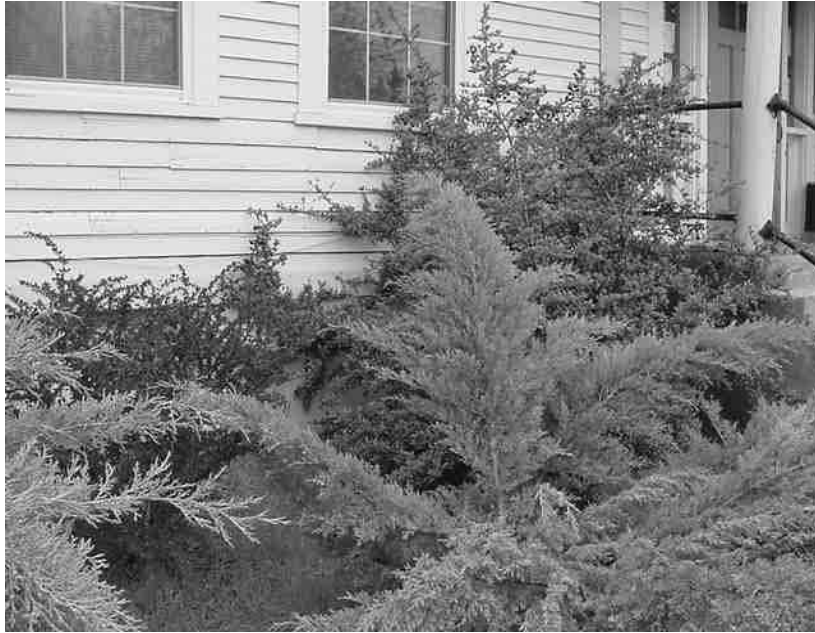
Picture 11

Shrubbery against the Foundation Wall

- c) Move foliage to a minimum five feet away from the foundation.

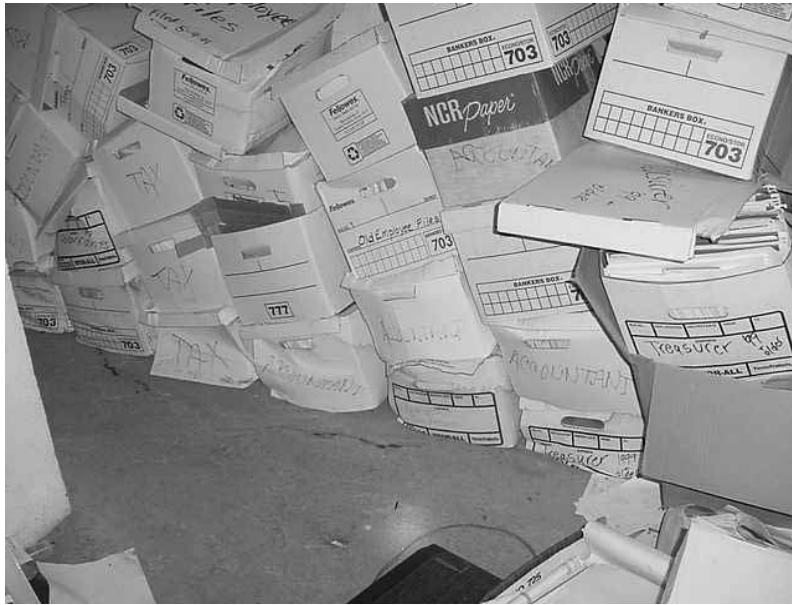
Picture 12

Materials Stored in Basement, Notes Water Stains On Boxes in Contact With Floor

- 9) Seal all holes in the exterior walls of building to prevent mouse and other rodent migration.
- 10) Remove mold colonized materials from the basement. Disinfect non-porous surfaces with an appropriate antimicrobial. If more extensive water damage/mold growth is found, remove mold-contaminated materials in a manner consistent with recommendations found in “Mold Remediation in Schools and Commercial Buildings” published by the US Environmental Protection Agency (US EPA, 2001). Copies of this document can be downloaded from the US EPA website at:

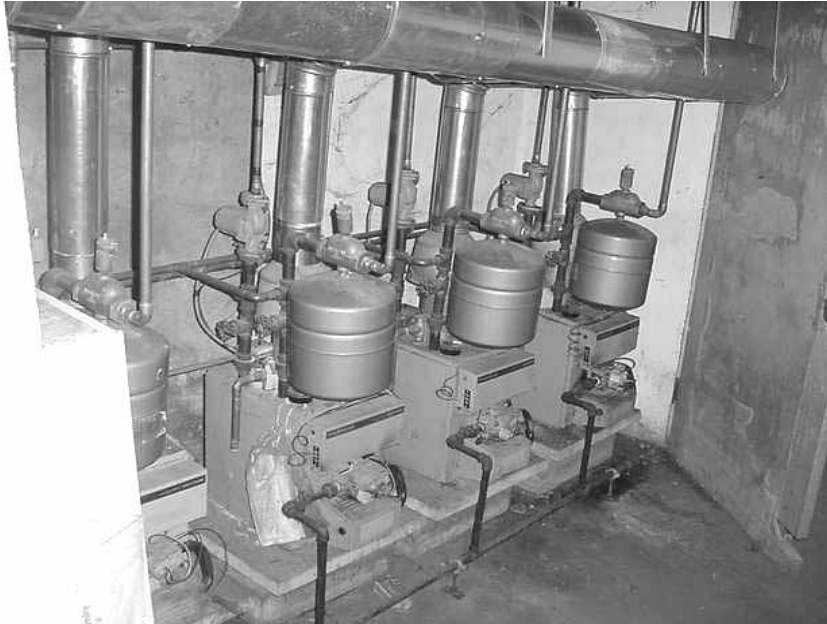
Picture 13

Boilers in Basement

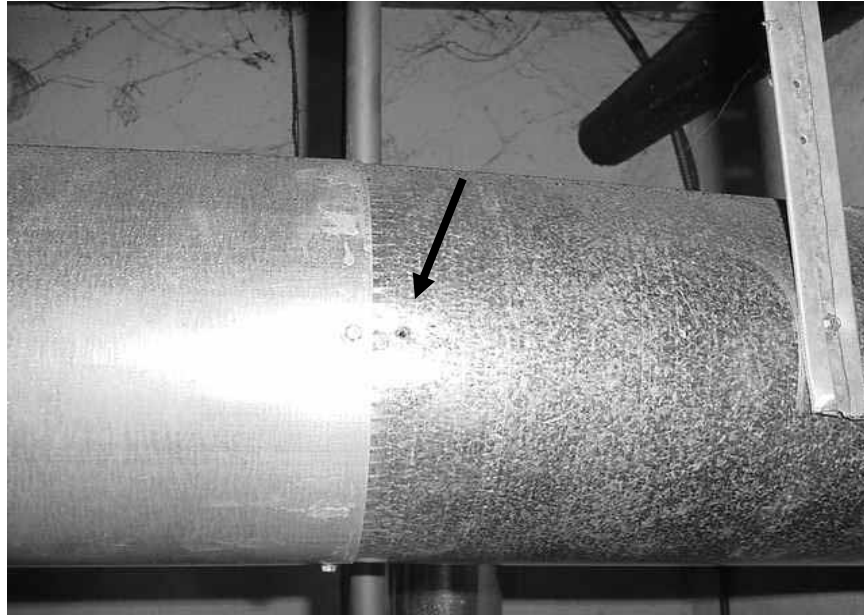
Picture 14a

Holes Were Noted In the Duct Connecting the Boilers

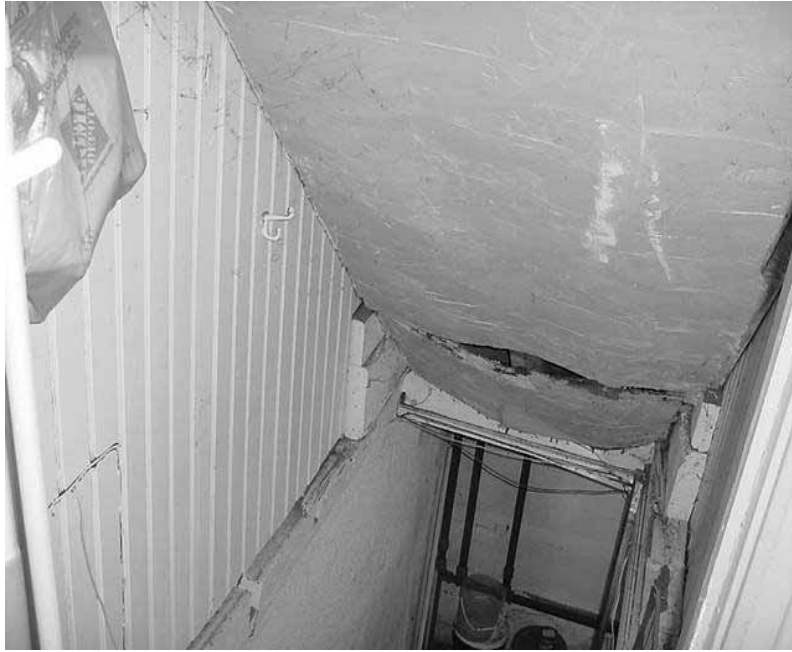
Picture 14b

Beaches in the Basement Stairwell Ceiling

- a) Install weather-stripping around the doorframe of the basement access door, as well as a door sweep at the bottom of the door.
 - b) Seal the holes in the ceiling

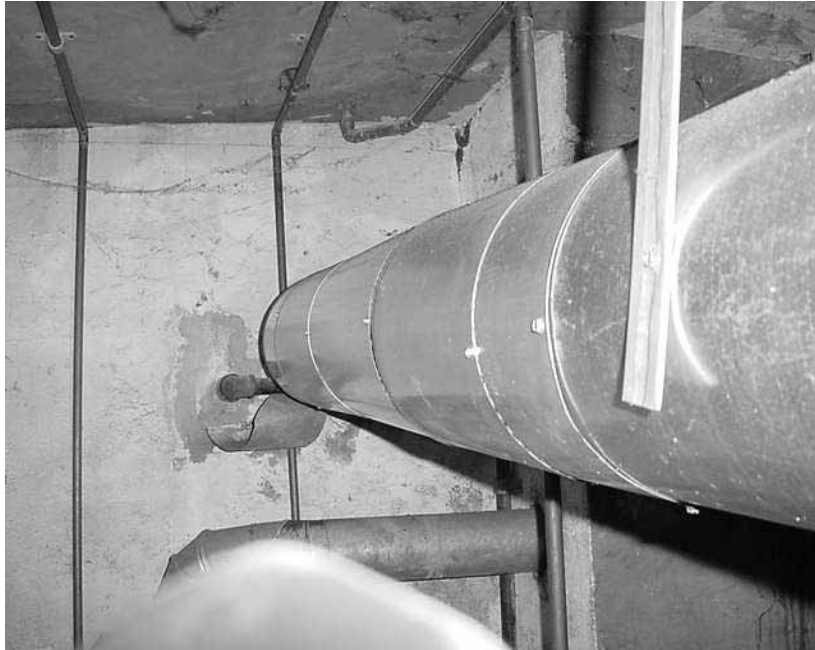
Picture 15a

Chimney Horizontal Ductwork

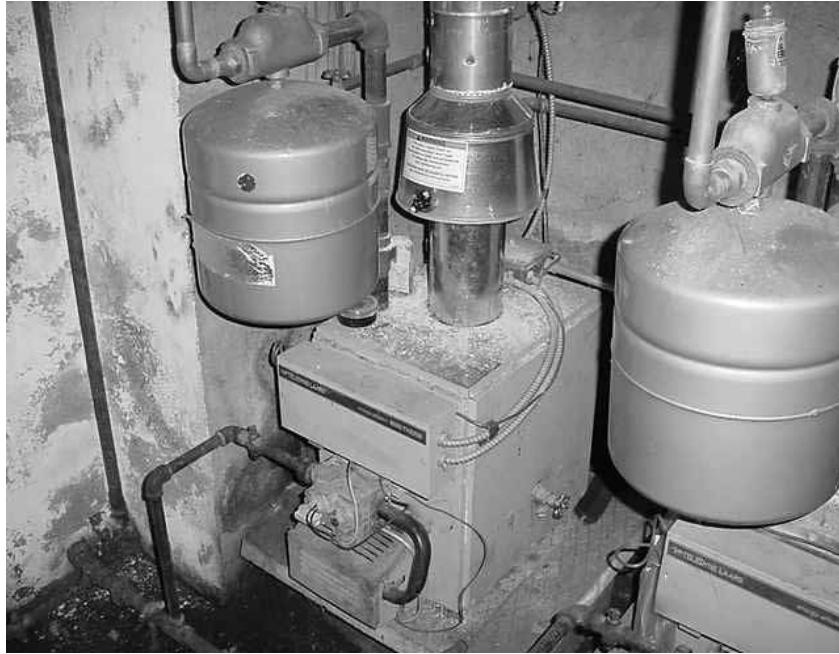
Picture 15b

Soot Accumulation below Exhaust Vent Bell

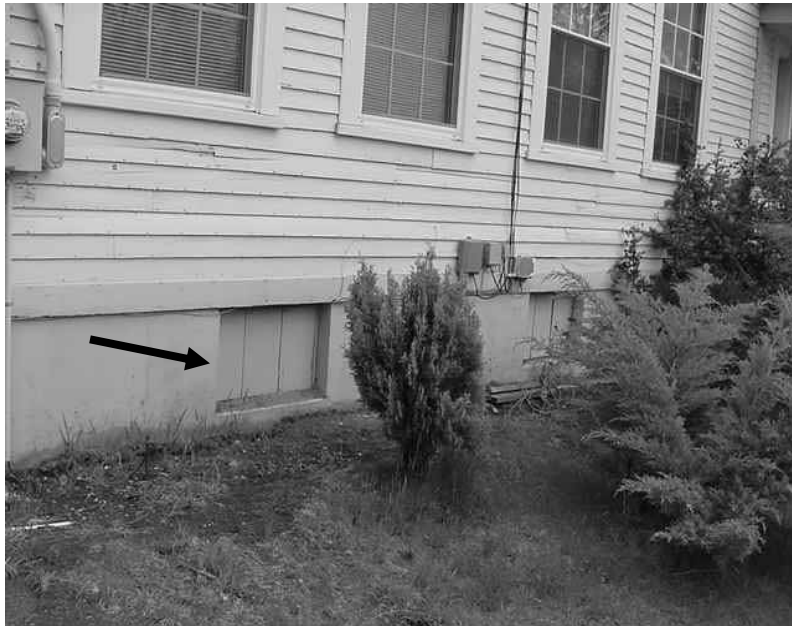
Picture 16

Combustion Air Vent for Boilers

- 5) Provide adequate combustion air to for the boilers. Consider reconfiguring the window in the boiler room to provide combustion air. Consult with the local fire prevention officer/building code officials to determine an appropriate method to provide combustion air for the boilers.

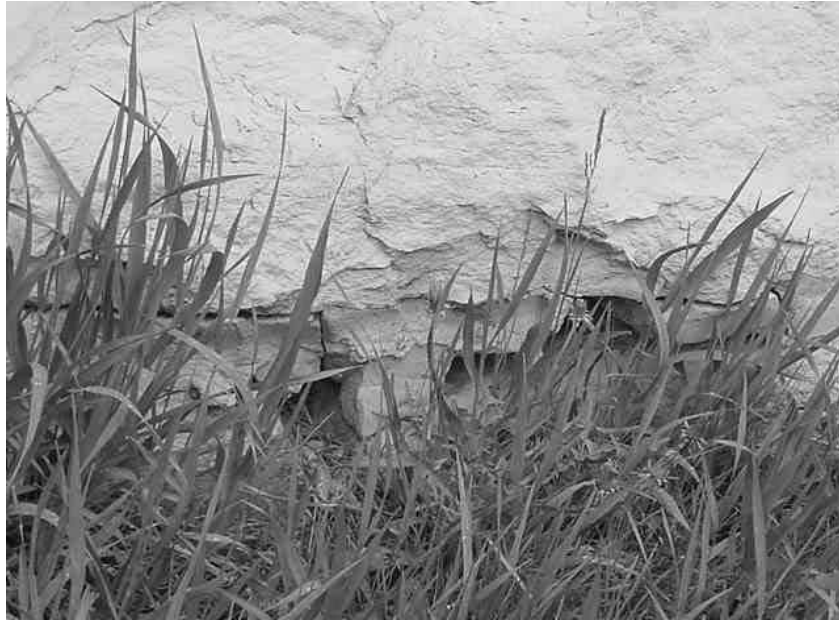
Picture 17

Holes in the Foundation

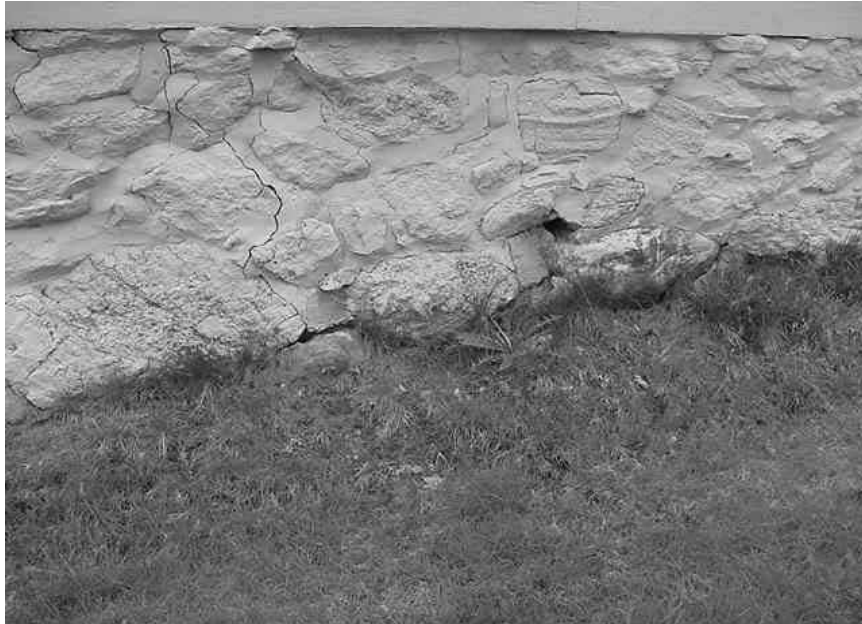
Picture 18

Holes in the Foundation

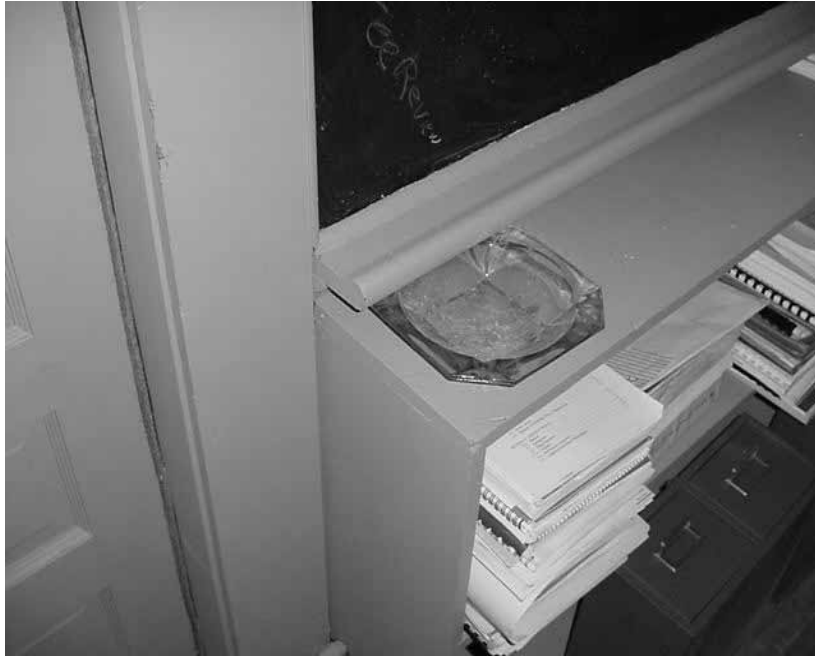
Picture 19

Used Ash Trays

- g) Reduce harborages (cardboard boxes) where rodents may reside (MDFA, 1996).
- 14) Comply with Massachusetts General Law Chapter 270, Sec. 22 (i.e., smoking in public buildings).

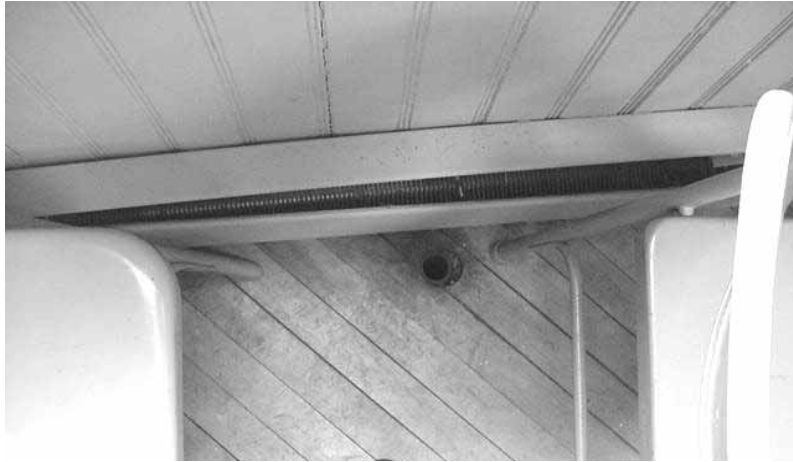
Picture 20

Open pipes from an abandoned heating system were noted in a number of areas (see Picture 22). Open pipes and spaces around pipes can serve as pathways for dust, dirt, odors and other pollutants to move from the floor/wall cavities into occupied areas.

Open Pipes of an Abandoned Heating System

- c) Sealing the spaces around utility pipes that enter the occupied space through the floor.
 - d) Seal all abandoned heating pipes.
- 7) Prevent water penetration into the basement. The following steps may be taken to prevent rainwater from downspouts and exterior wall runoff from penetrating through the foundation.

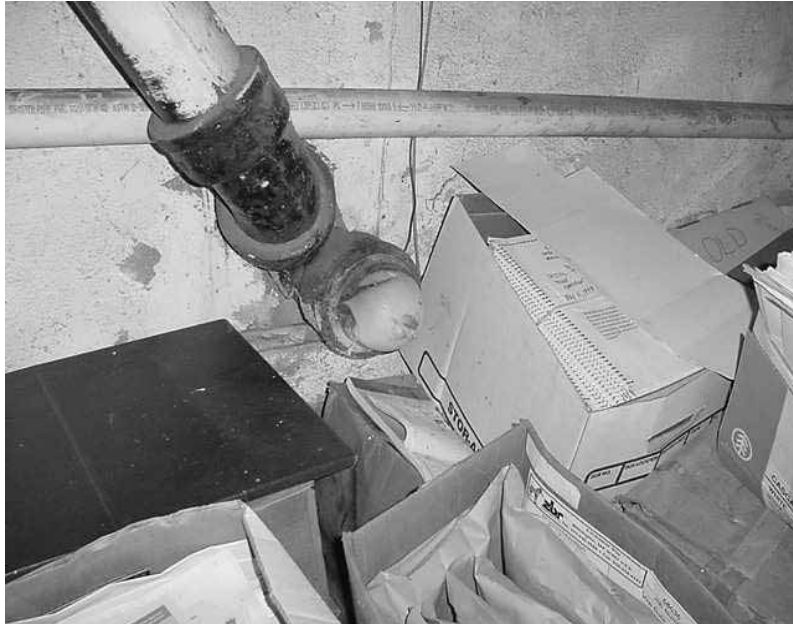
Picture 21

A sewer pipe cleanout appears to be sealed by the insertion of a plastic bottle (see Picture 23). Sewer gas is an eye, nose and respiratory irritant. Sewer pipes should be capped appropriately to prevent odor back up into the boiler room.

Sewer Pipe with Plastic Bottle Inserted into the Cleanout Opening
